August 2, 2020

## PROPERTY CONDITION ASSESSMENT

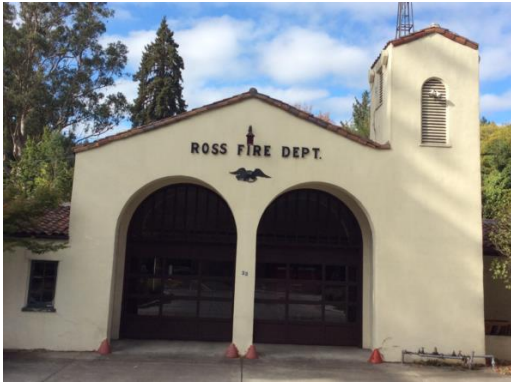
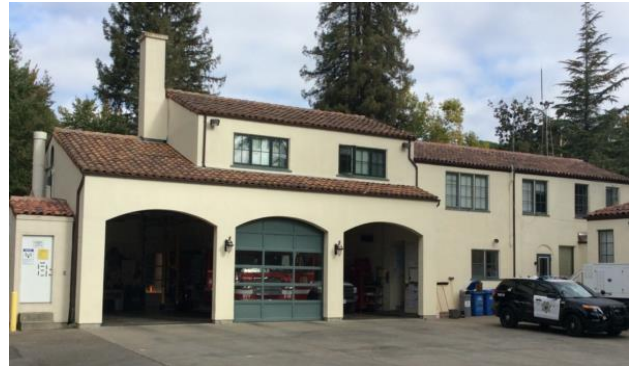
### ZFA Structural Engineers Conditions Assessment Report dated February 13, 2017

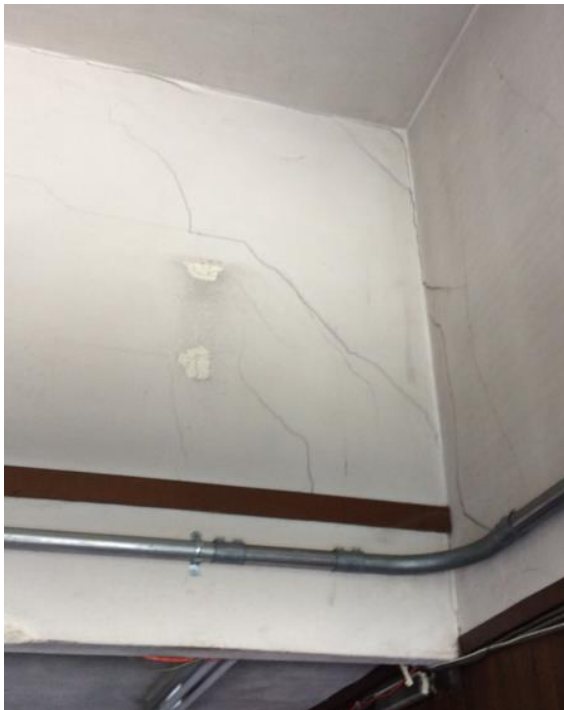
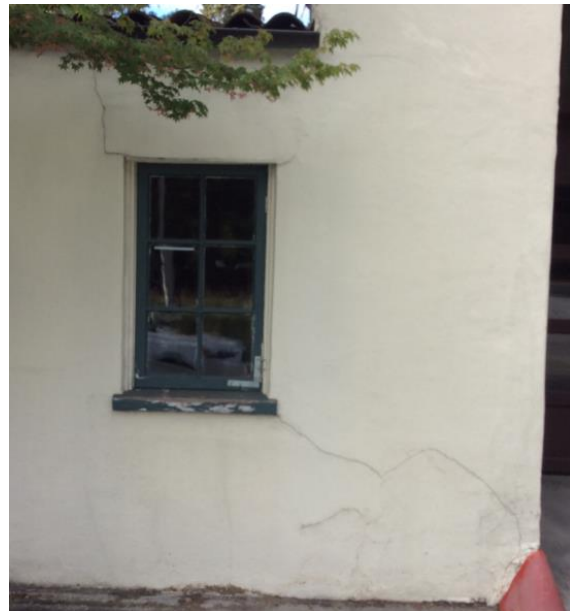
Image 11 and 12: Central firehouse – stucco cracks

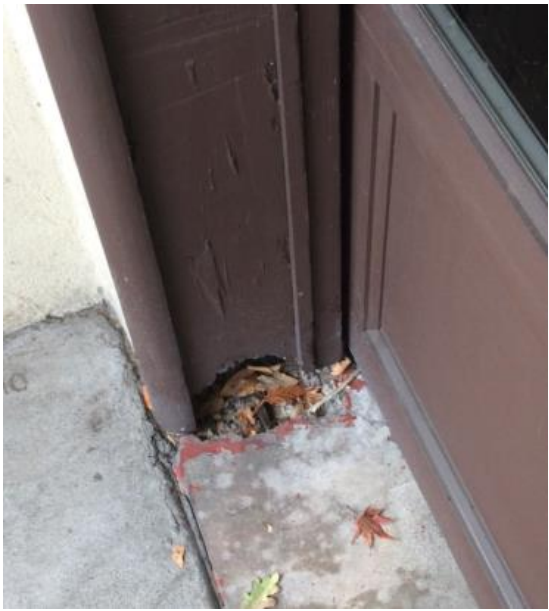
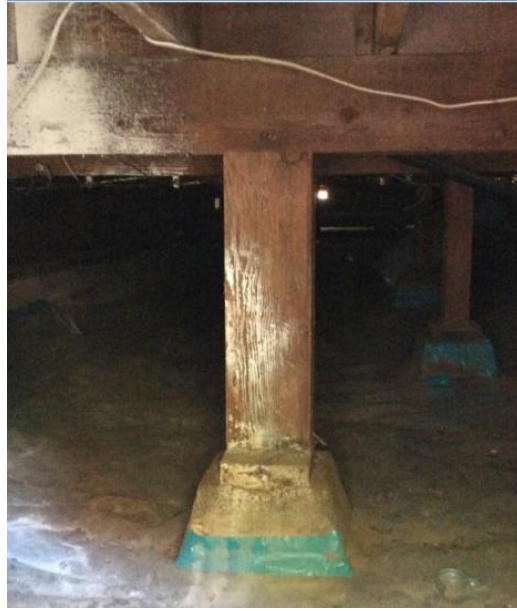
Image 13 and 14: Central and North Wing – decay and floor girder/post

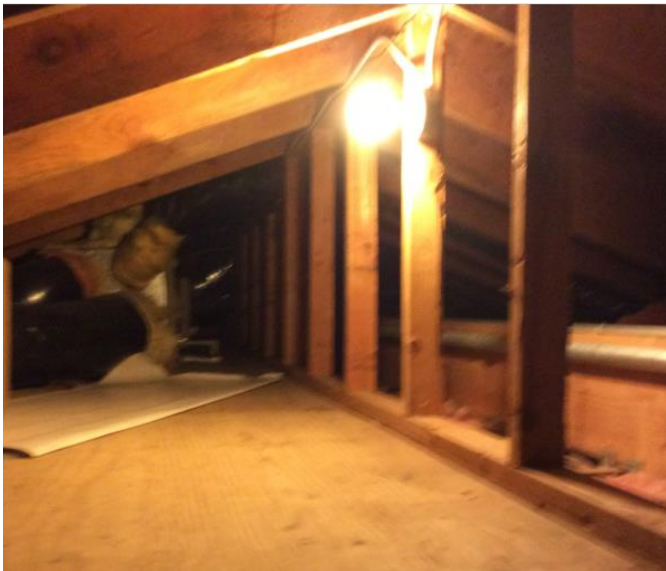
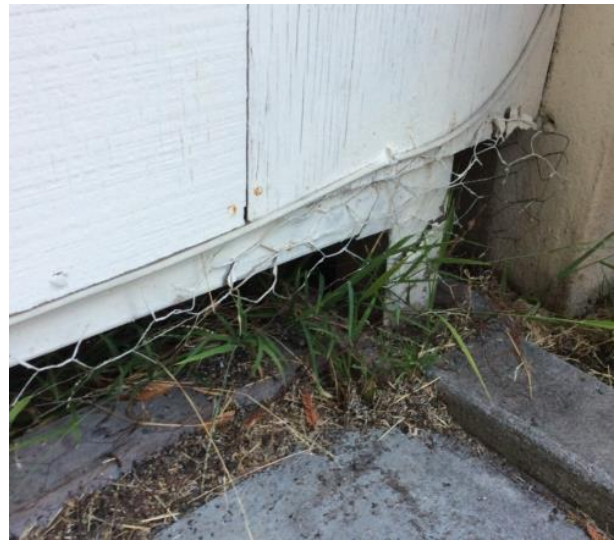
Image 15 and 16: Expansion and Infill – Roof framing and infill construction

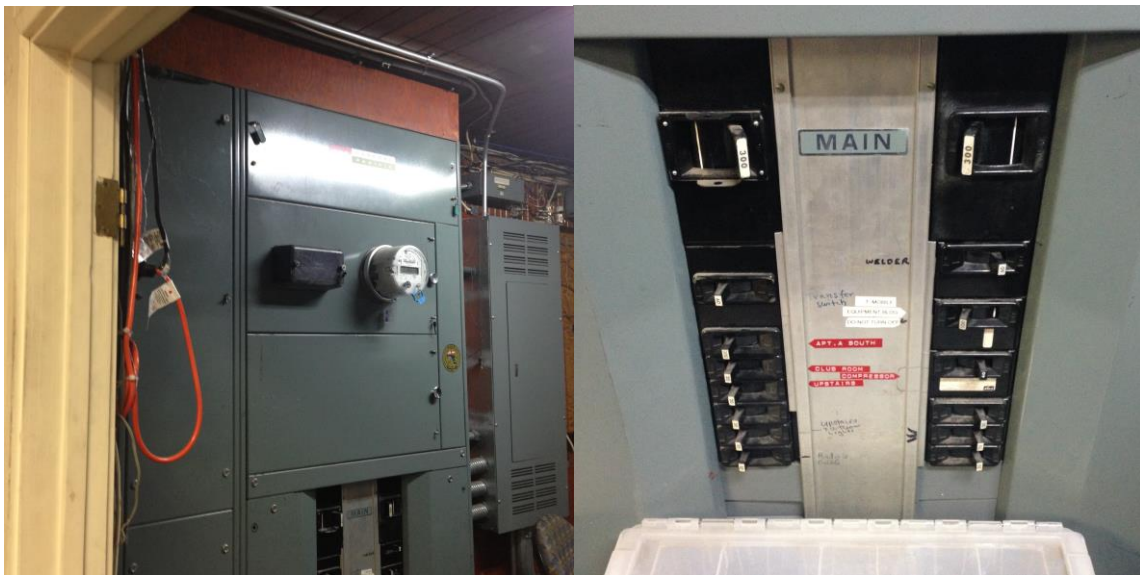
- b. A small 120/240V, single-phase exterior service is fed underground and is located on the backside of Apartment A. The service was originally fed overhead and the former service conductors are cut at the weather-head. The service has a Smart Meter #1007823862. It is unclear as to what this service feeds, but might feed the panels in the apartments.

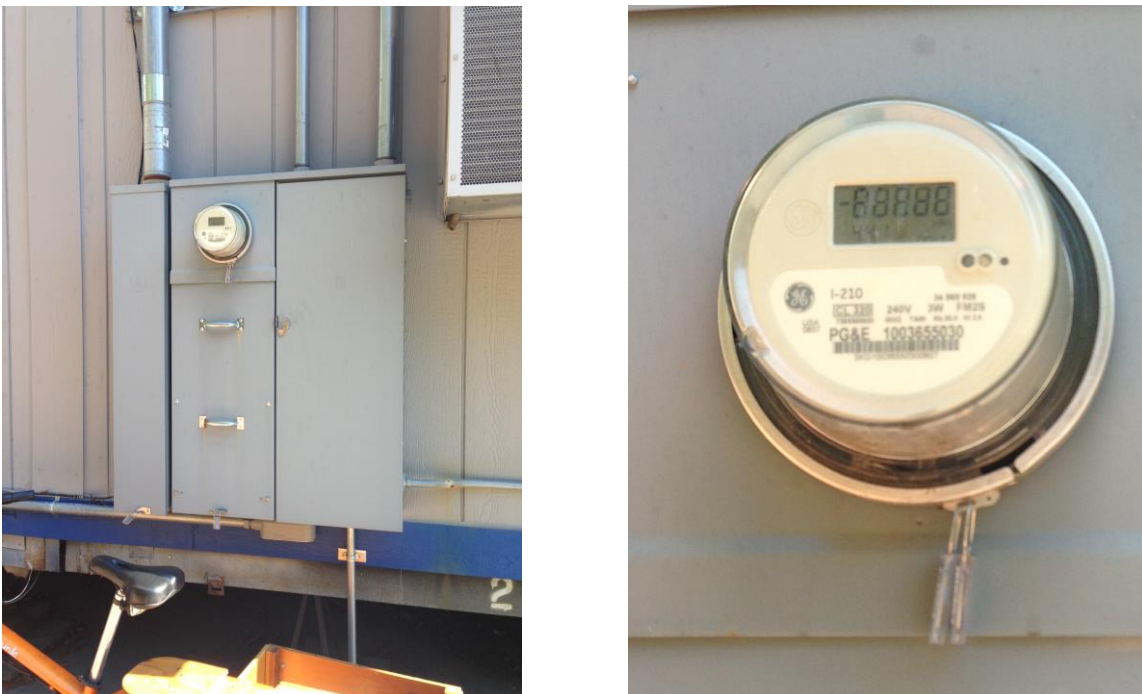
## **2. Electrical Distribution**

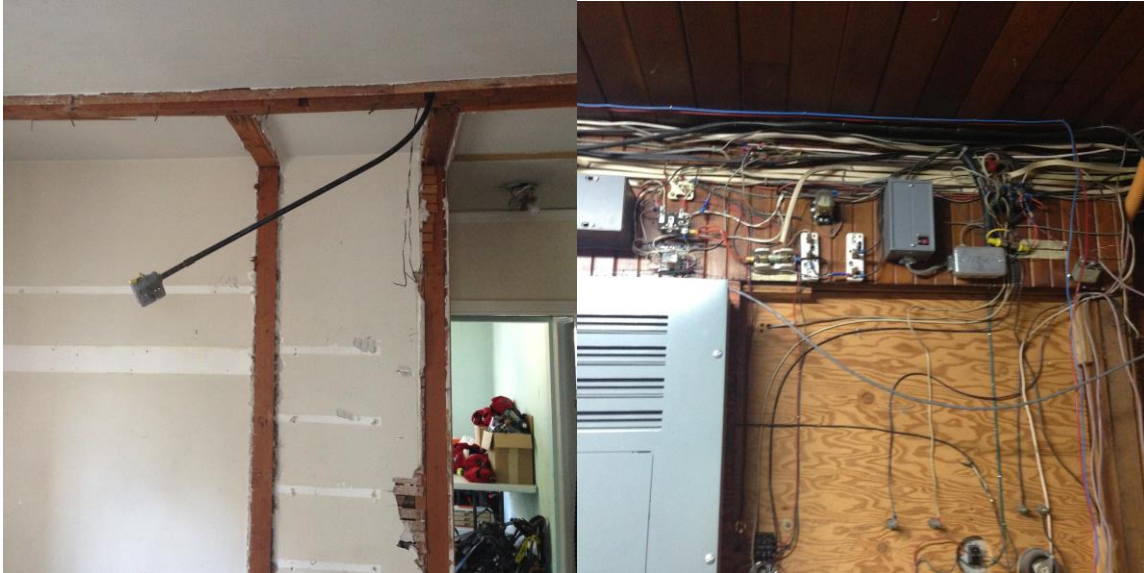
## 7. Emergency Generator

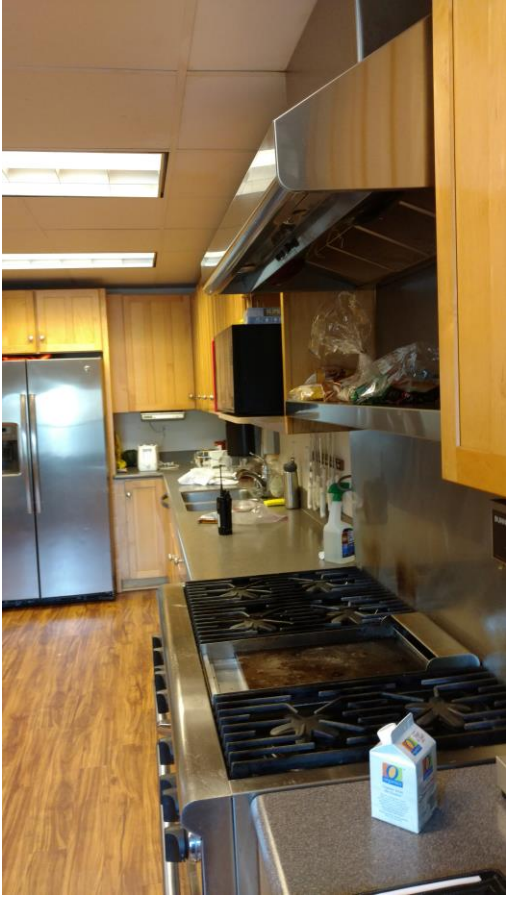
- Domestic water entrance should be protected from possible vehicle damage and replaced with modern valves and pressure regulator.

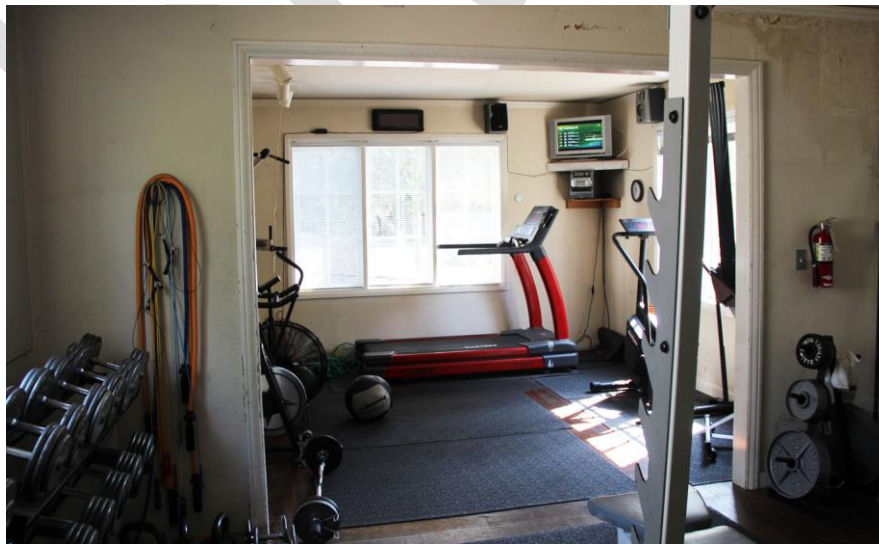
Figure 39. Dining room and living room in north wing.

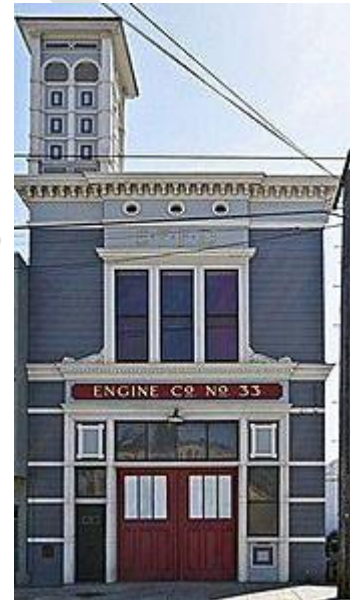
Figure 43. SFFD Engine Co. No. 33

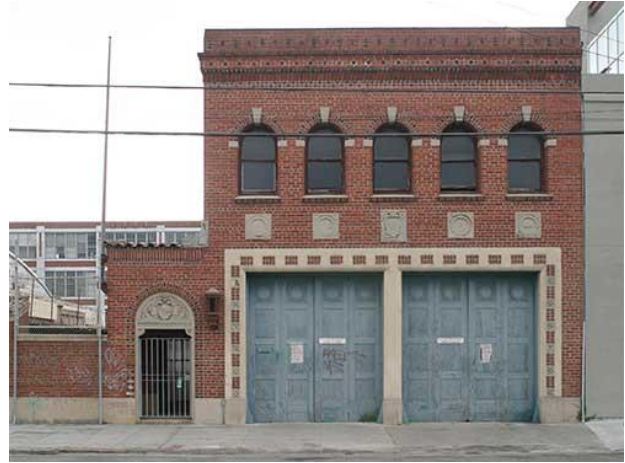
Figure 44. SFFD Engine Co. No. 16

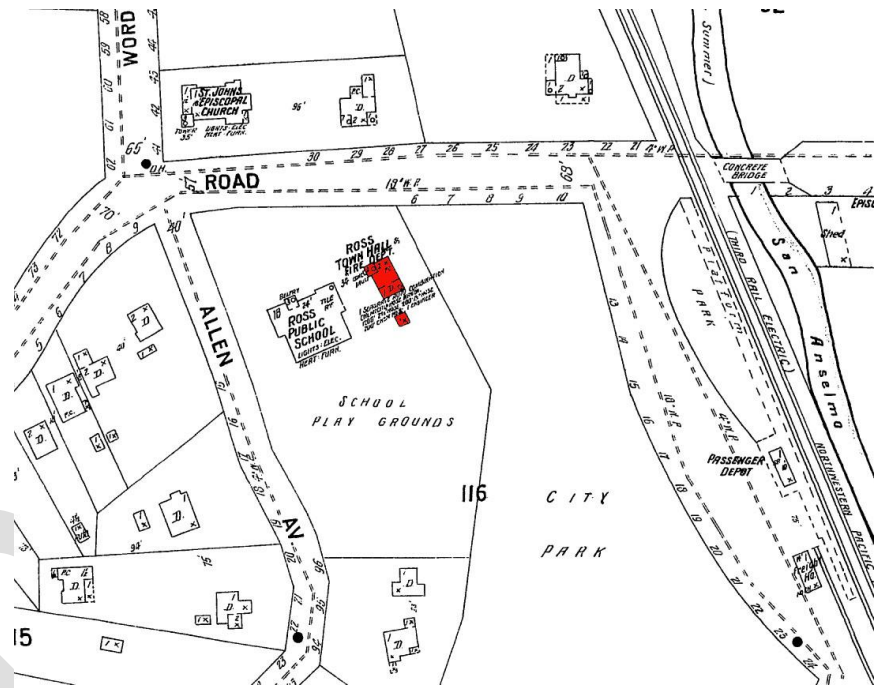
**Figure 47. 1914 Sanborn Map showing original location of Ross Town Hall and Fire Department**

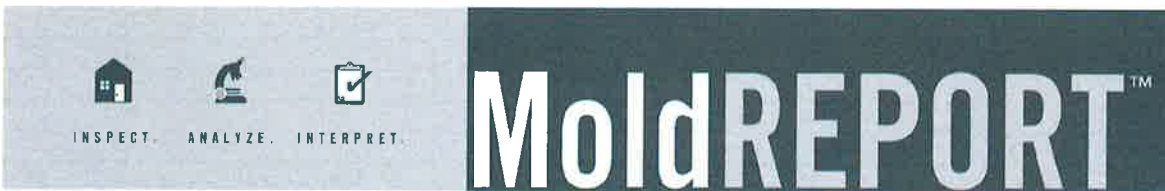
**Eurofins EMLab P&K**

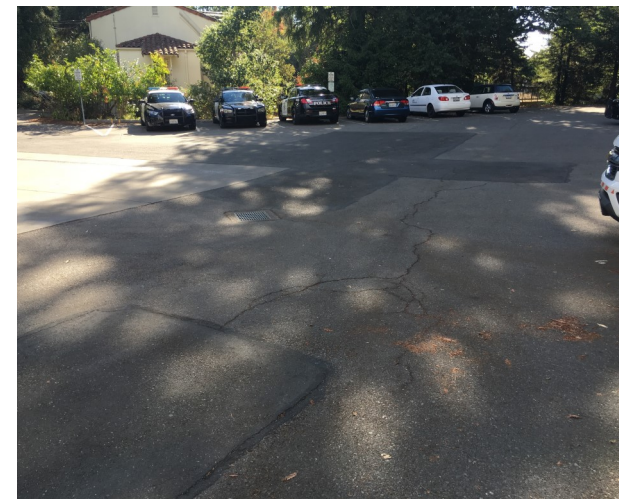
Entry to Zfire House Kitchen

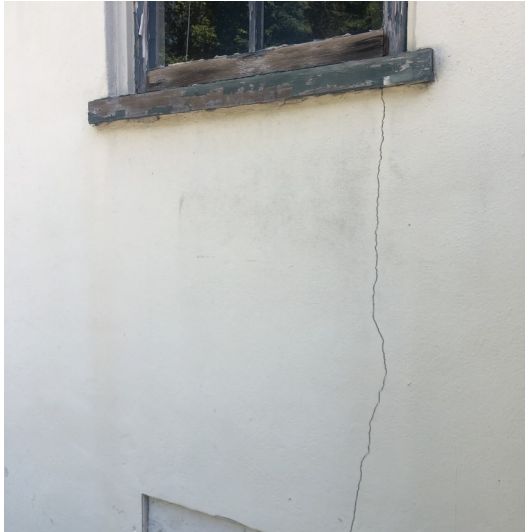
Typical Plaster Cracking

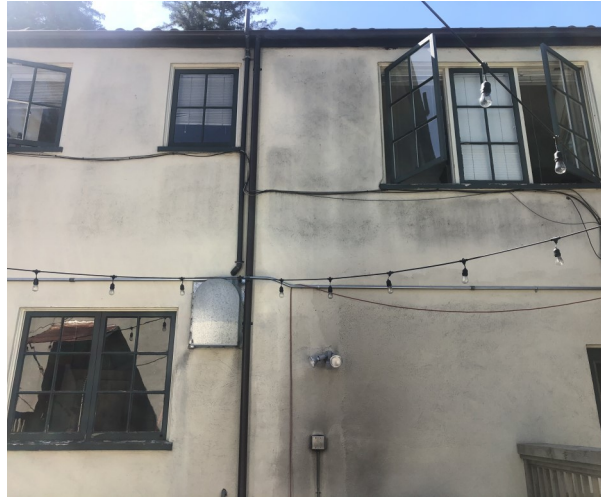
Exposed wiring, faded paint

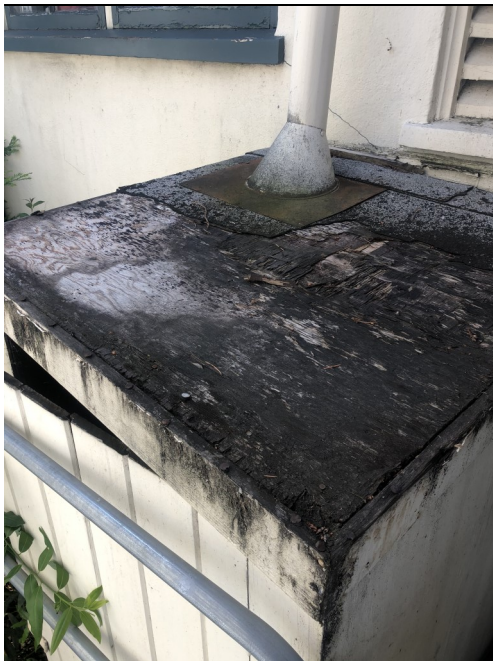
Roofing needs replacement

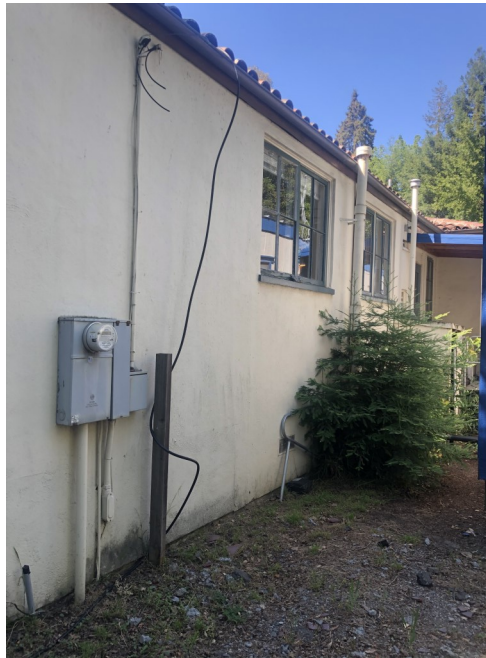
Soil contact with plaster

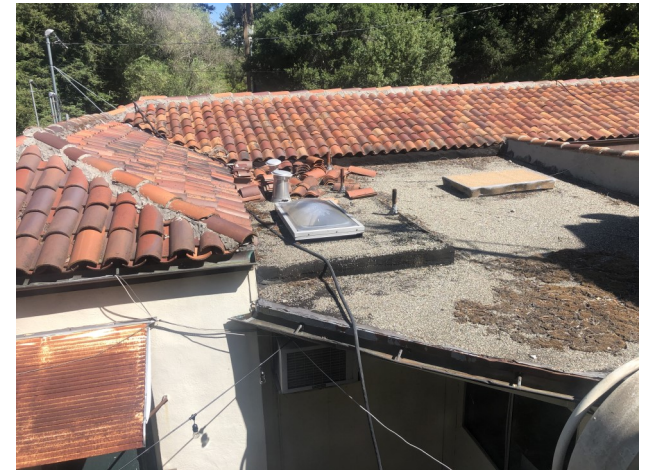
Roofing in need of repair, misc. exposed wiring.

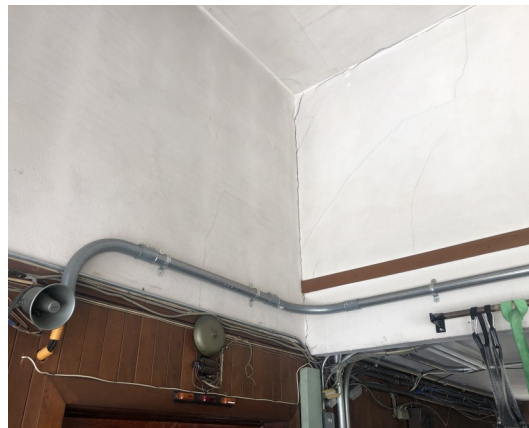
Interior plaster cracking

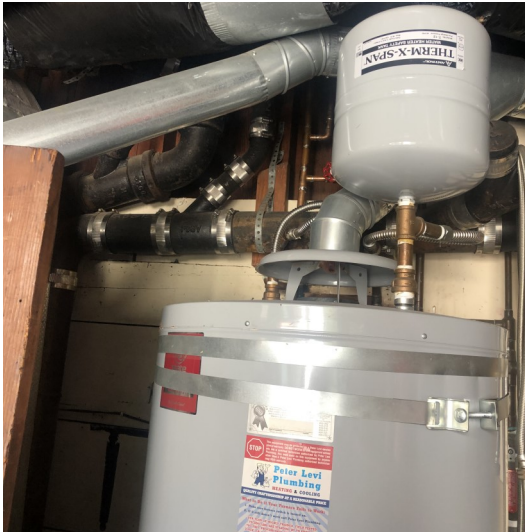
Fire House Water Heater

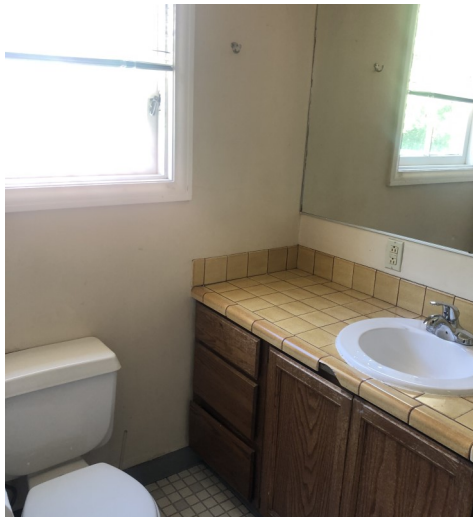
Broken counter top tile

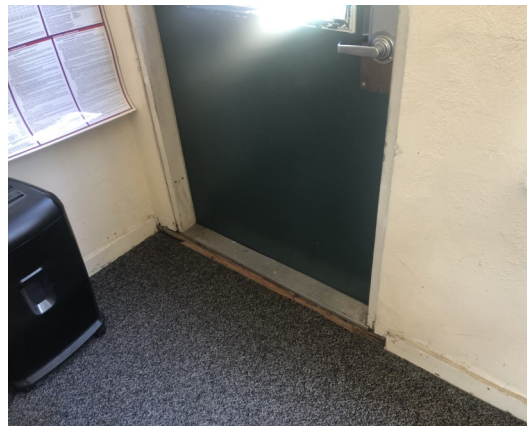
Water staining at threshold

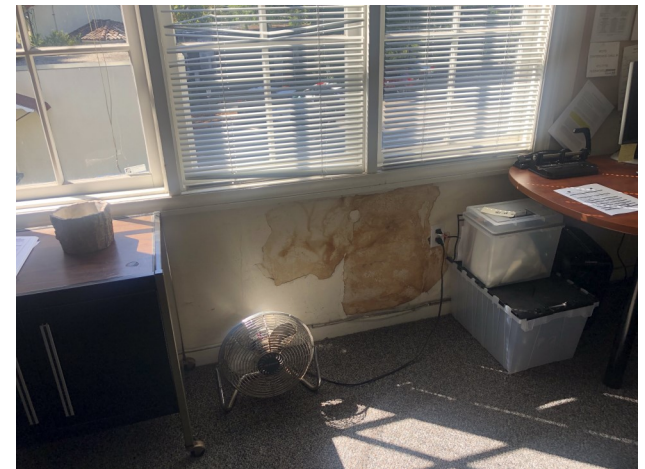
Water damage at exterior wall

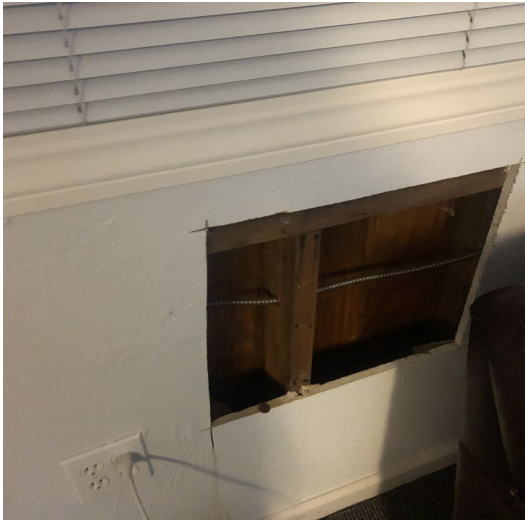
Portion of wallboard has been removed.

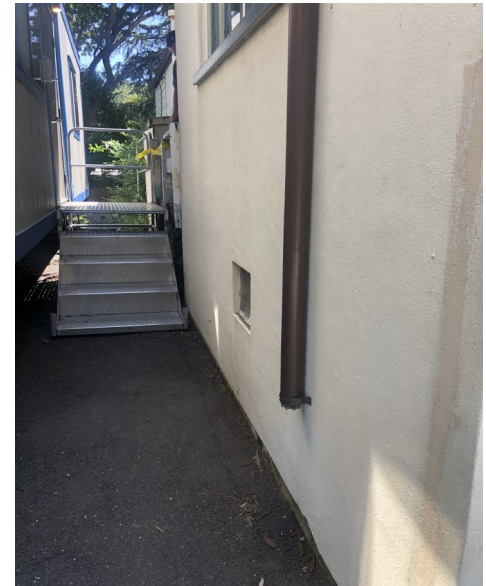
Unconnected rain water leader.

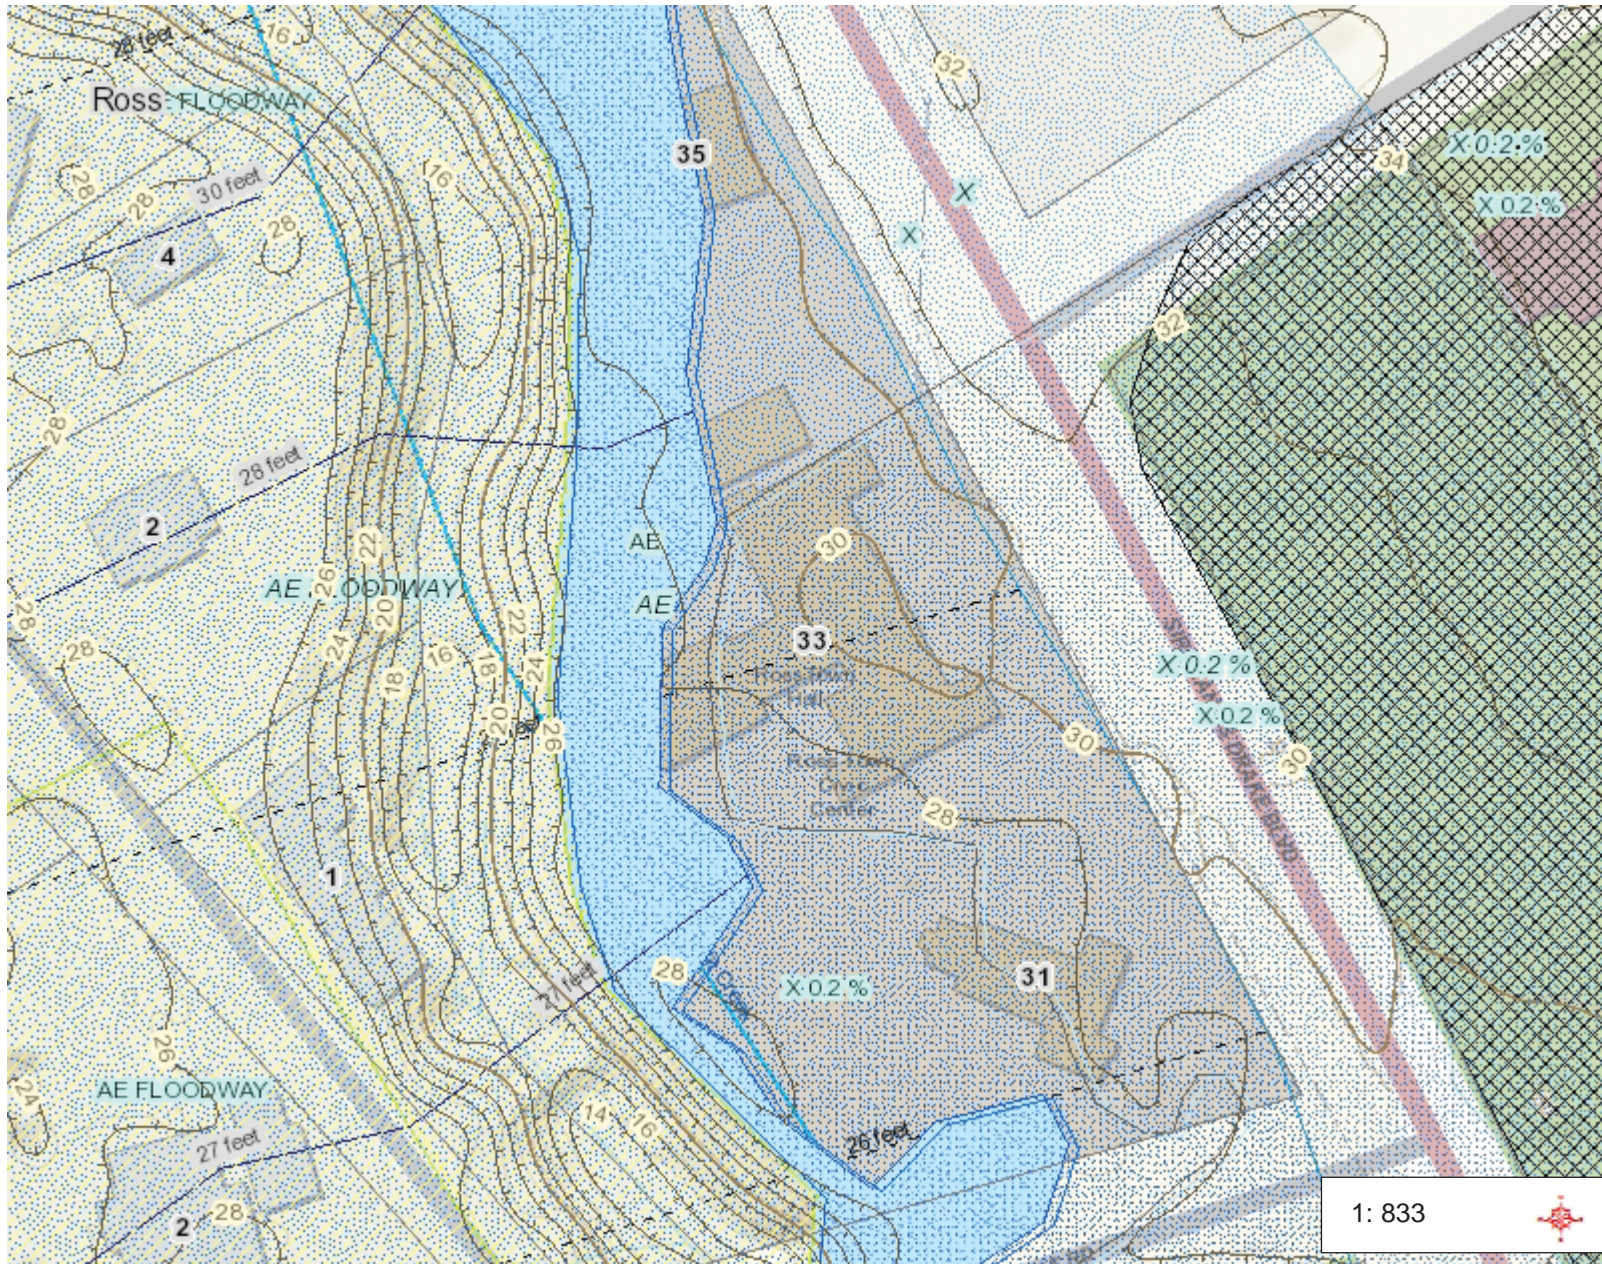
**APPENDIX L**  
**Maps and Site Plan**
